TWR-64222

## Final Postflight Hardware Evaluation Report RSRM-29, STS-54

September 1993

**Final Postflight  
Hardware Evaluation Report  
RSRM-29, STS-54**

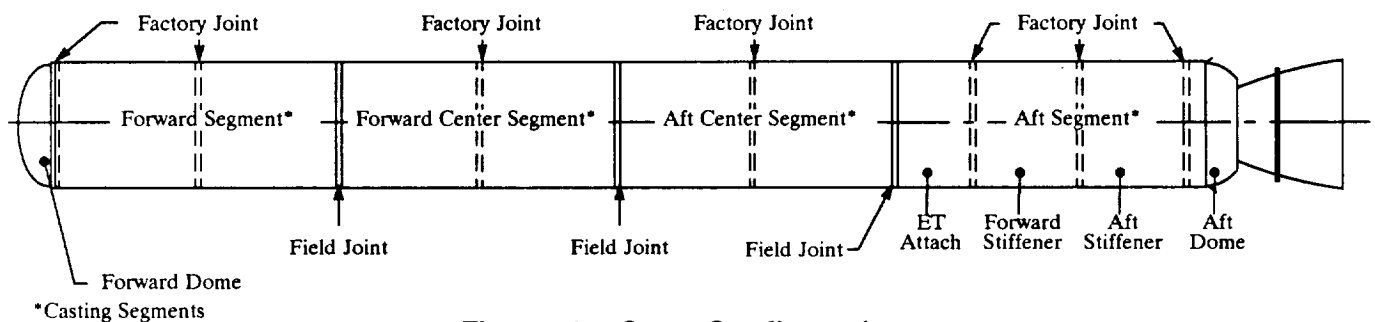
Figure 1. Case Configuration

Figure 1 shows the RSRM Case Configuration.

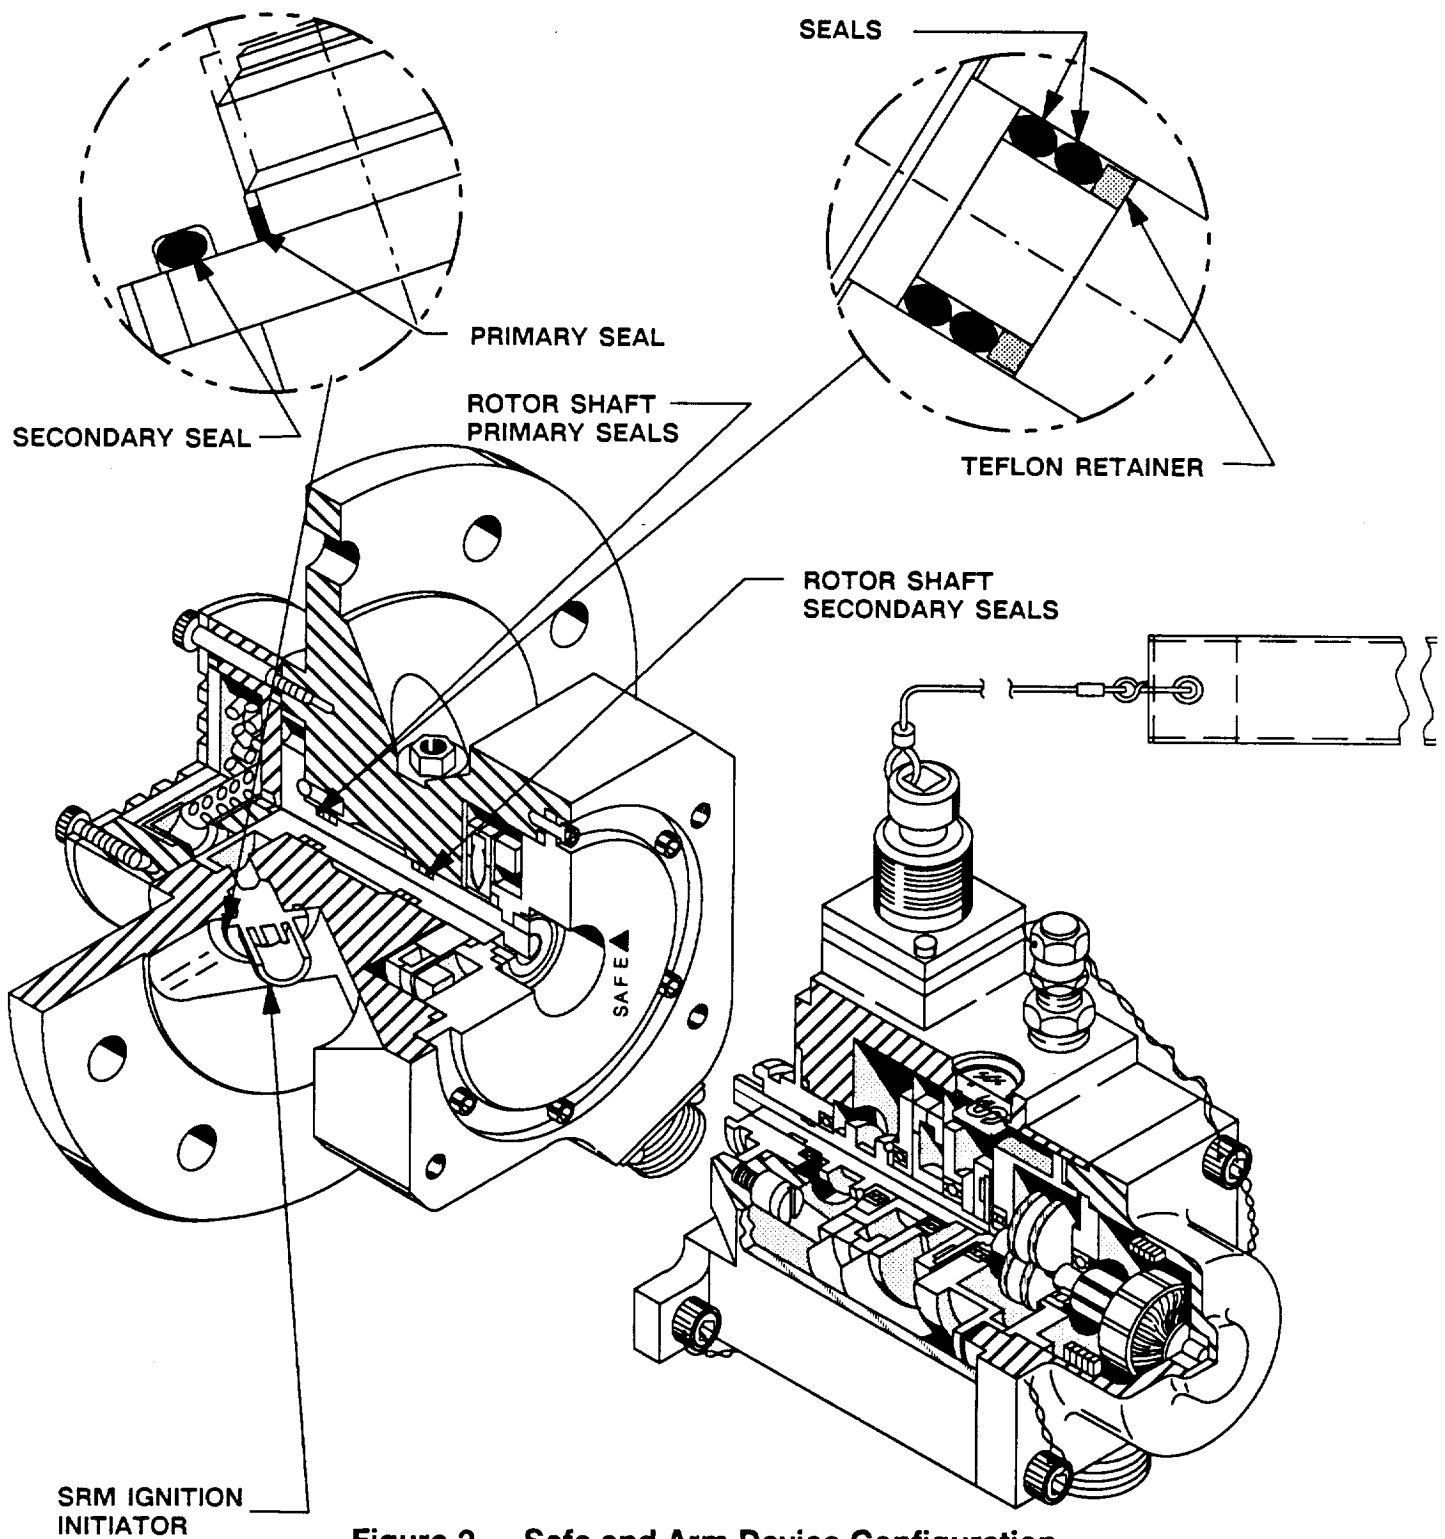
**Figure 2. Safe and Arm Device Configuration**

Figure 2 shows the S&A configuration. The S&As were disassembled on January 28, 1993, at the Clearfield H-5 facility. The following is a summary of the assessment observations.

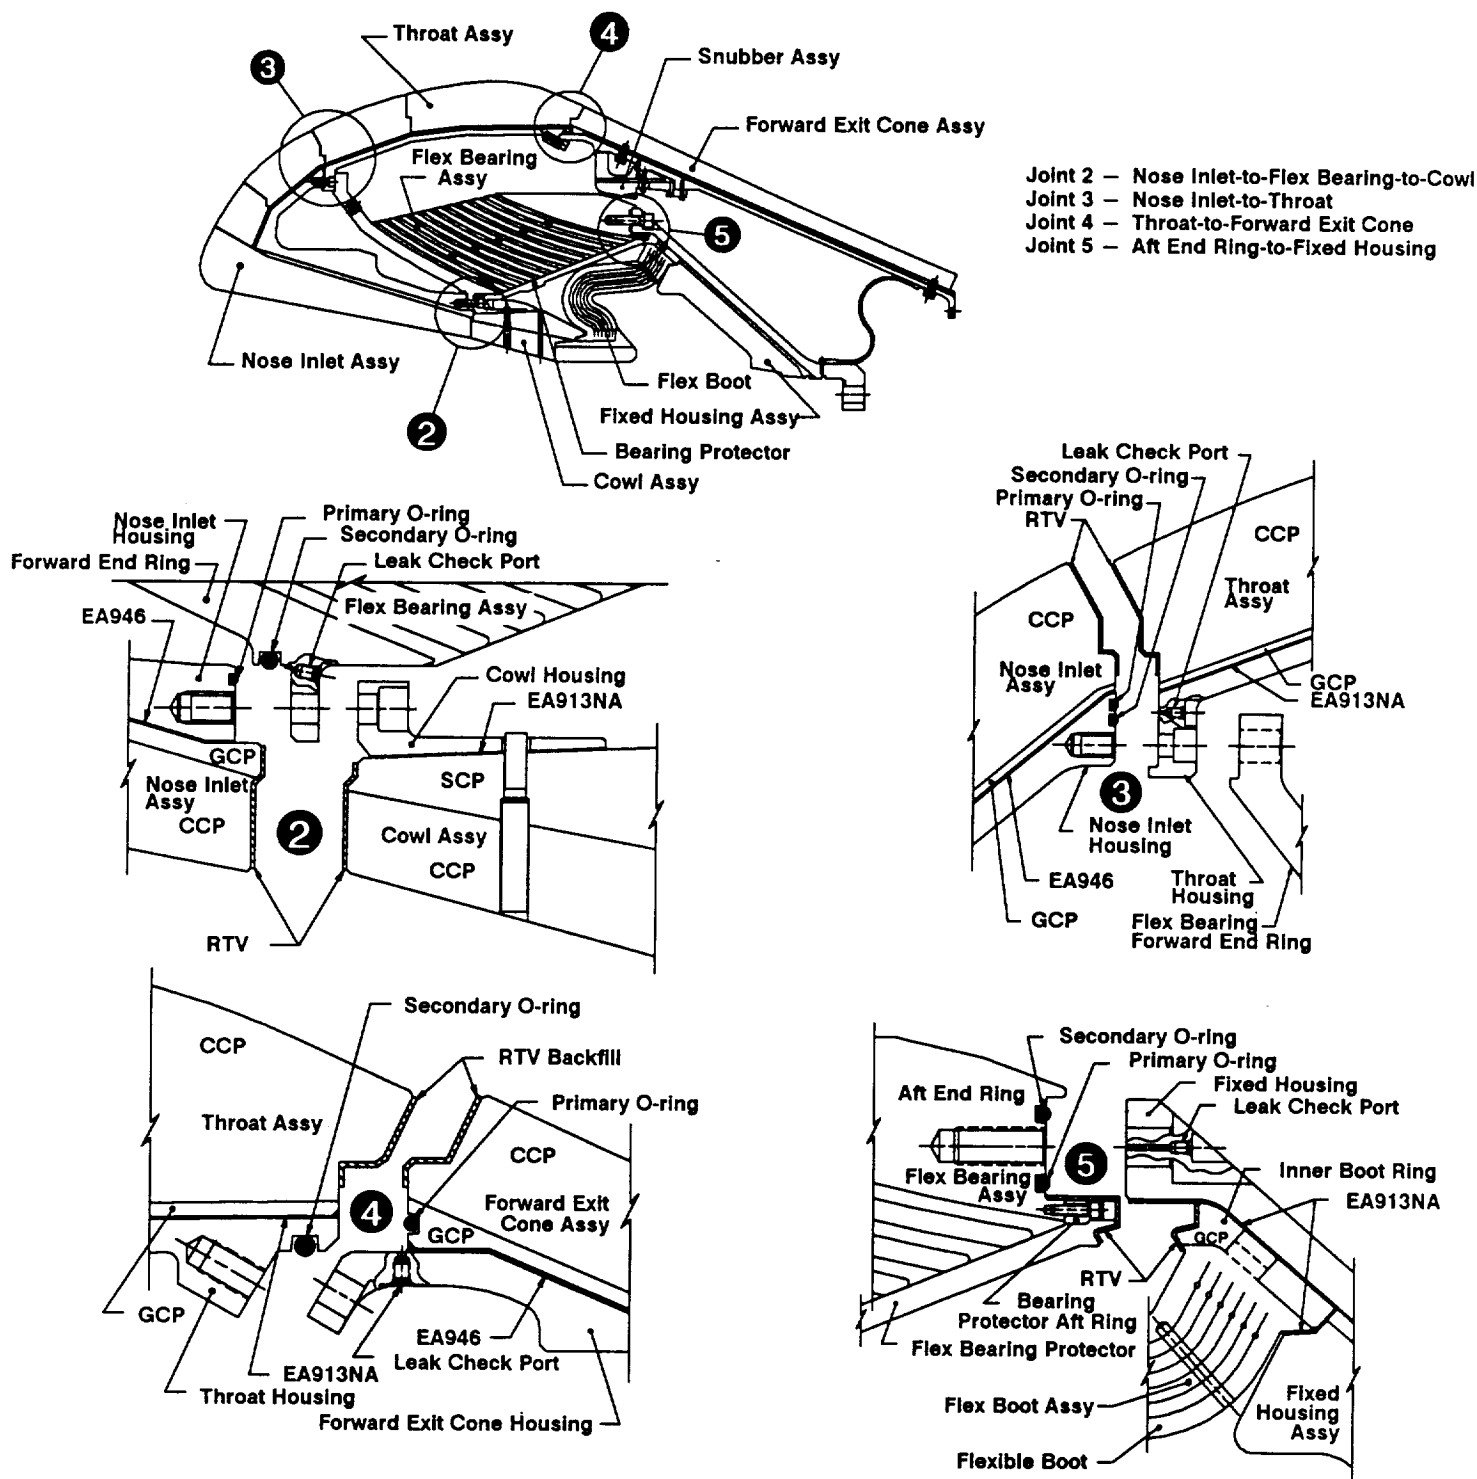
Figure 3. Internal Nozzle Joint Configuration

Figure 3 shows the RSRM-29 internal nozzle joint nomenclature and details the internal nozzle joint configuration used in this report. The nozzles were off-loaded at Clearfield H-6 on January 25, 1993.

The internal nozzle joints were disassembled on January 27-28, 1993, at the H-6 facility in Clearfield. The condition of the RSRM-29 nozzle joints was generally typical of previous flight nozzles. RTV was below the char line in all joints. The primary and secondary O-rings in all joints showed no signs of blowby, erosion, heat effects or disassembly damage. There was no significant metal hardware damage.
